Drainage CCTV Survey Report

Drain Technology (UK) Ltd

**Made Up Cottage
Dark Lane
Haunted Village
Bucks
HP12 4TD**

Pre-Purchase Survey

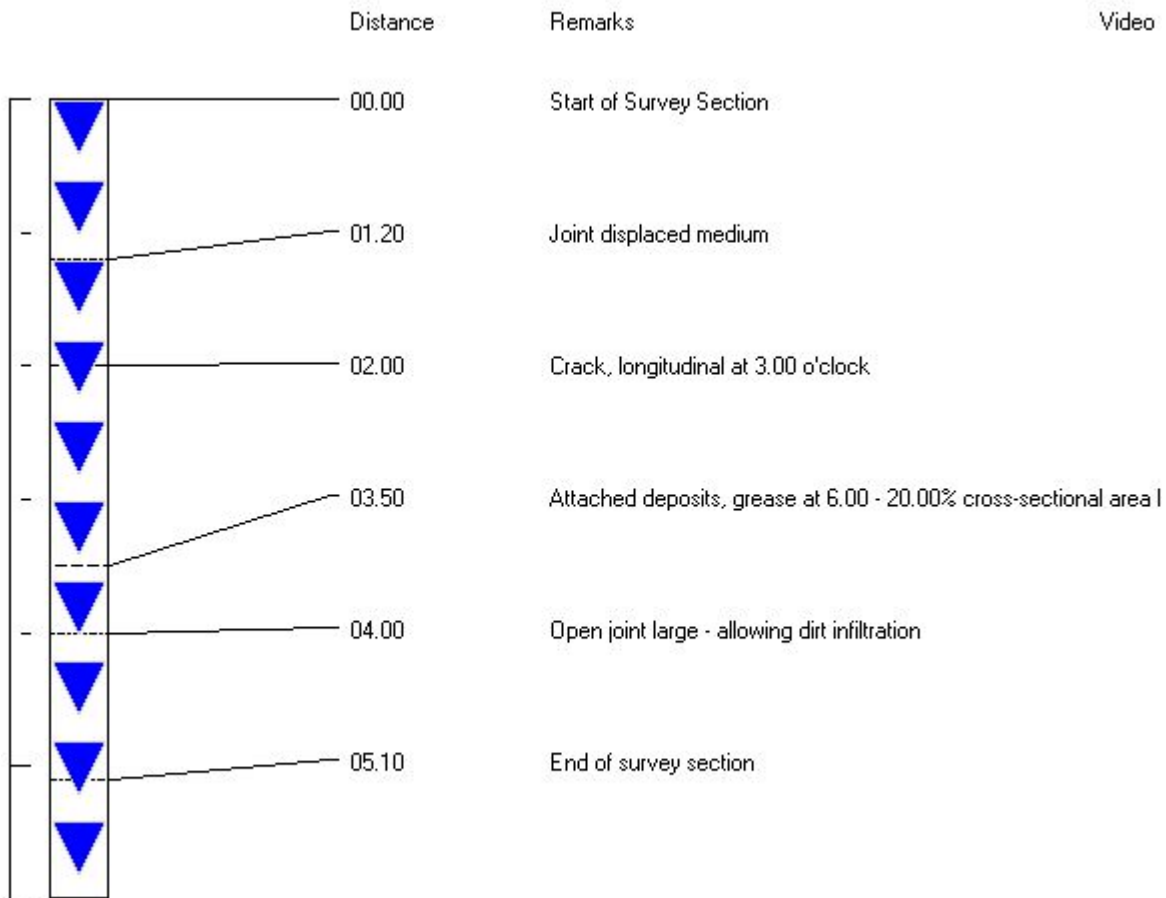
Schematic Diagram for Section 3-2

Section : **3-2** **Downstream from Manhole 2 to Manhole 3**

<i>Position (mtrs)</i>	<i>Code</i>	<i>Details</i>
0.00	ST	Start of Survey Section
1.20	JD(M)	Joint displaced medium
2.00	CL	Crack, longitudinal at 3.00 o'clock
3.50	DEG	Attached deposits, grease at 6.00 - 20.00% cross-sectional area loss
4.00	OJ(L)	Open joint large - allowing dirt infiltration
5.10	END	End of survey section

Pipe requires cleaning to remove grease build up and then a patch repair inserted in the run to seal open joint.
